Learning from Undoing: The Reimagined Library for 21st Century Uses and Users

Design Advocacy Group Presentation

December 5, 2019

the historic
closed stacks
of the parkway
central library
1901
vine street

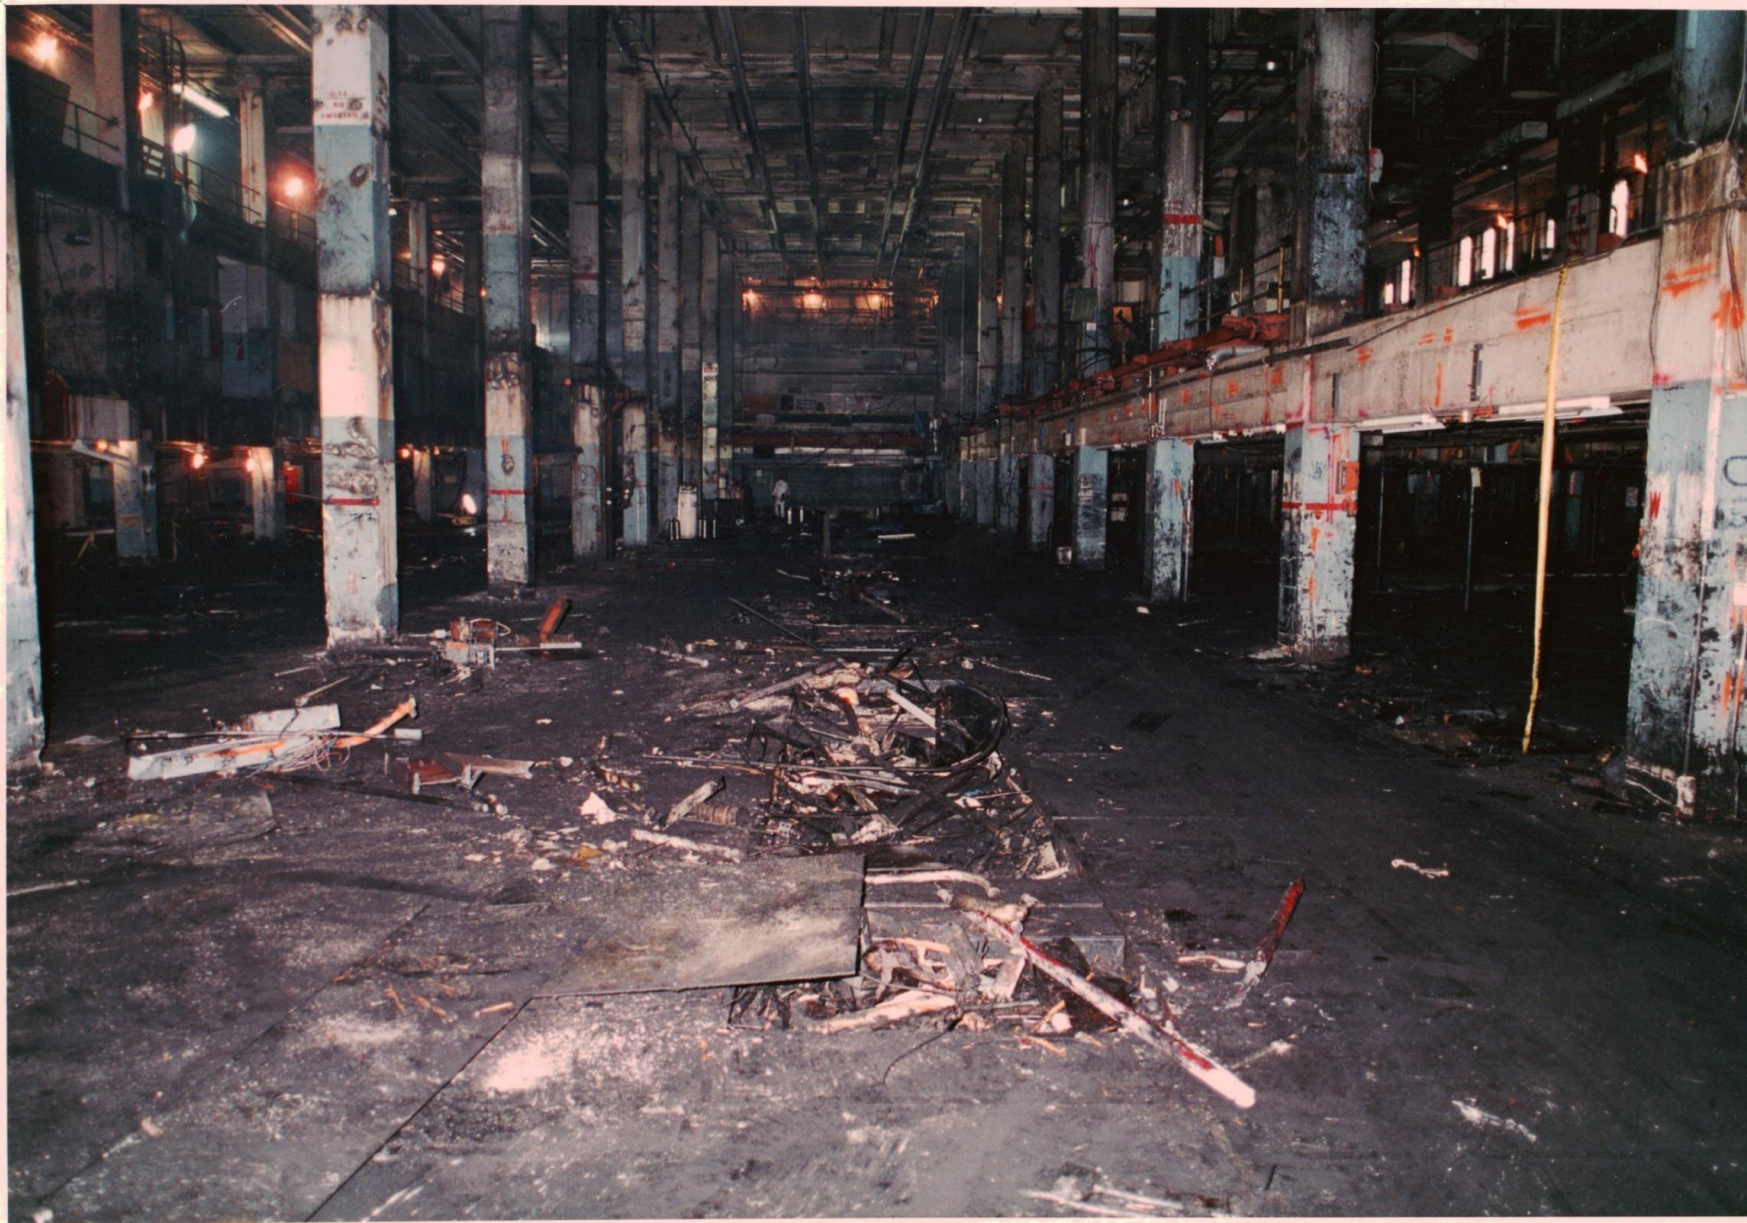
400 Bldg. reel rm.
C line, looking east.
